Mechanical Tests and Failure Analysis on Selected Components of the Class 60 Armored Vehicle Launched Bridge (AVLB) During the Class 70 Modification Program

ARL-TR-1269

December 1996

Weapons and Materials Research Directorate, ARL

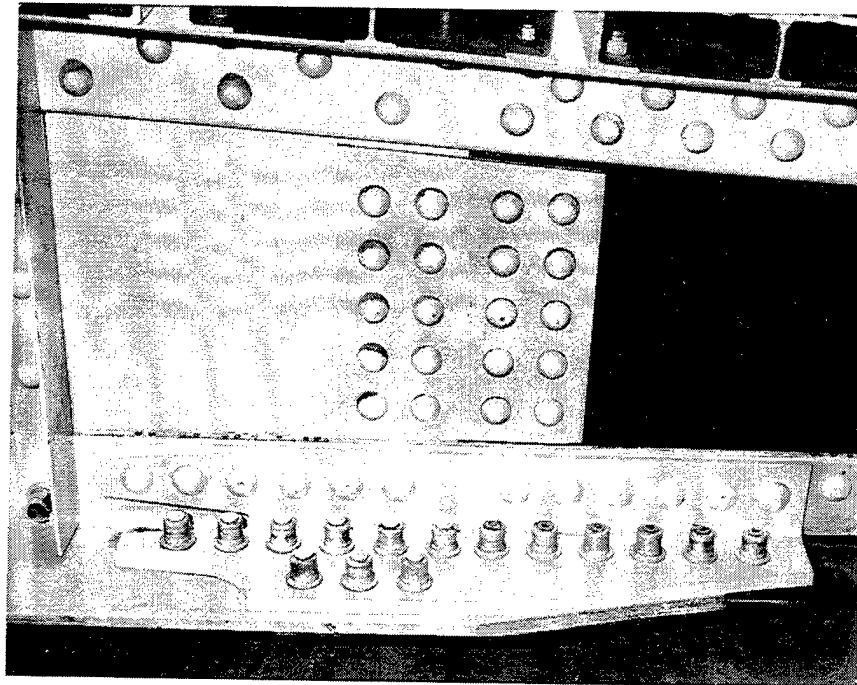
- Larger and stronger aluminum alloy 7050-T76511 angle splices at the joint where the steel ramp end section was spliced to the aluminum section of the end panel assembly (see Figures 119 and 120). Also, a 1/4-in-thick T-1 steel bottom plate was used in place of alloy 2014-T6 at the splice joints.

Figure 119. Close-up view of the modified larger angle splice fastened to the bottom chord angles and girder plates at the spliced joint. This is where the steel ramp end section (dark area at right) was spliced to aluminum section on left. It was made of stronger alloy 7050, and the Huckbolt fasteners were used as seen with the flanged collars. There is no sharp notch in the new angle splice as was seen in the original splices that sometimes were cracked (see Figures 2 and 120).

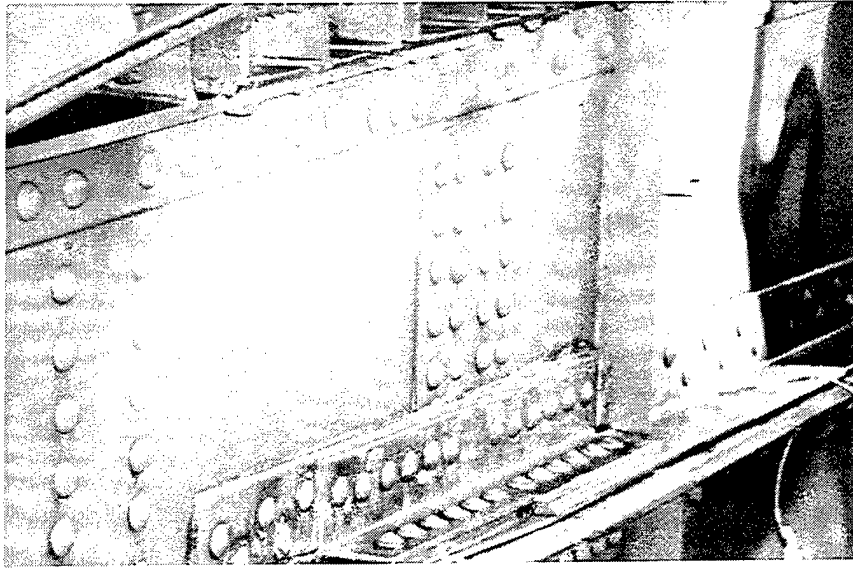
Figure 120. A view of the original angle splice on the current Class 60 AVLB for comparison to the larger modified splice in Figure 119. It contains the sharp angular notch in the cutout on the bottom angle leg. Note the use of the hot-driven aluminum rivets in the splice.

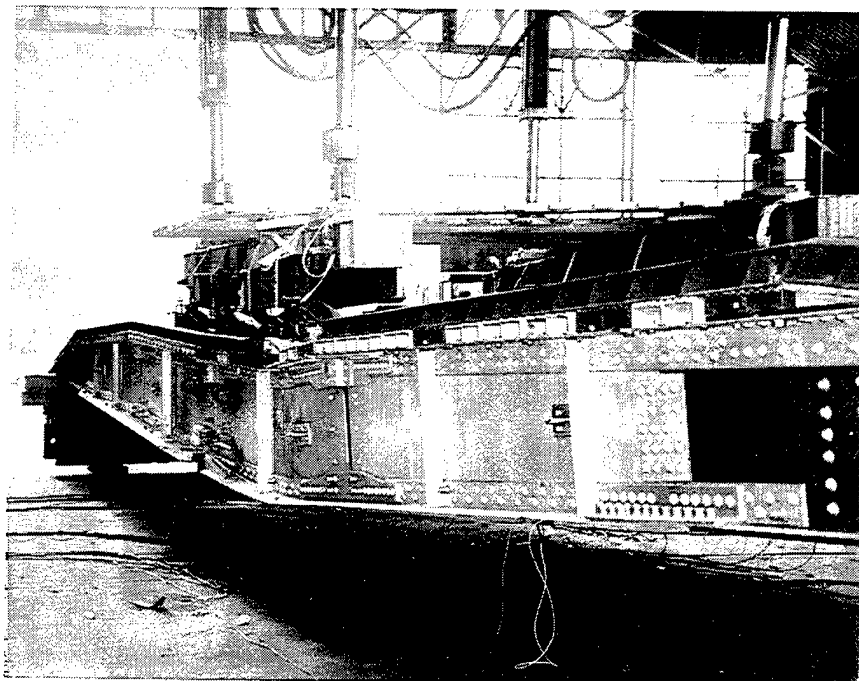
The prototype No. 2 Class 70 Modified AVLB arrived at Belvoir from ANAD for static overload tests and the ultimate failure test. It was inspected for visible cracks before and after the overload tests. No cracks were found before and after the 131-, 145-, and 158-ton overload tests. For the ultimate failure, the loads, starting above the maximum overload load, were applied at 10-ton increments for 10 min each at the midspan until the bridge failure occurred. While the load was increasing from 180 tons to 190 tons, the modified bridge buckled suddenly at about 190 tons (more than twice the Class 70 load) in the top chords of both female bridge sections, causing the girder aluminum plates also to buckle outward or inward from top to bottom (see Figures 121–124). The buckling occurred near the outer or middle footpads of the special loading device on each treadway at the midspan of the bridge. Other damages observed after the failure were the following: a 6-in-long crack in the inside corner at the bottom of an inboard vertical aluminum structural angle of the center interior cross brace inside the center panel of one female bridge section; a broken upper corner of the aluminum plate in two transverse braces; cracks at

Figure 121. A side view of the collapsed No. 2 Class 70 modified AVLB after the bridge failure test. It buckled in the top chords and girder plates in the center panel assembly of the female bridge section.

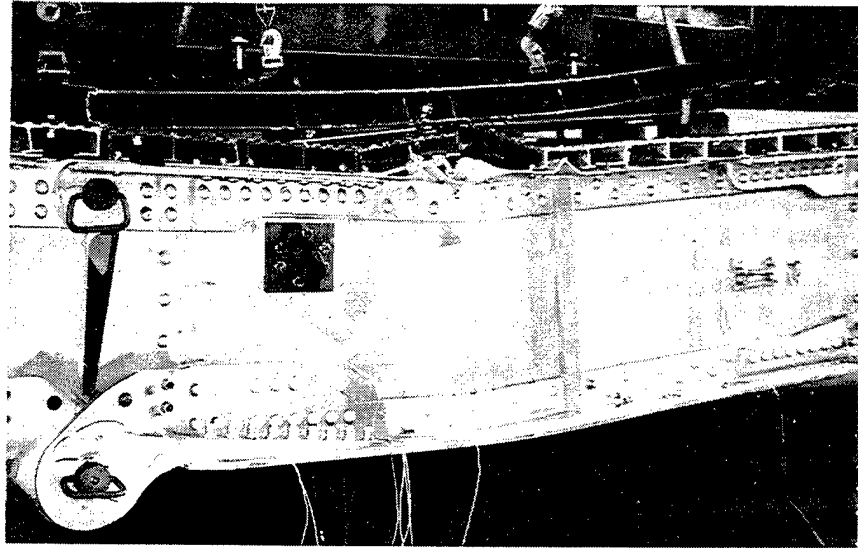
Figure 122. Close-up view of the buckled area in the No. 2 bridge in Figure 121. Note the extensive damages to the top chord, girder plate, extruded aluminum deck panels, and steel curb. The modified bottom chord angles did not crack, but bent at the buckled area. The buckling occurred closer to the center hinges of the female bridge section than in the other female section in Figure 124.

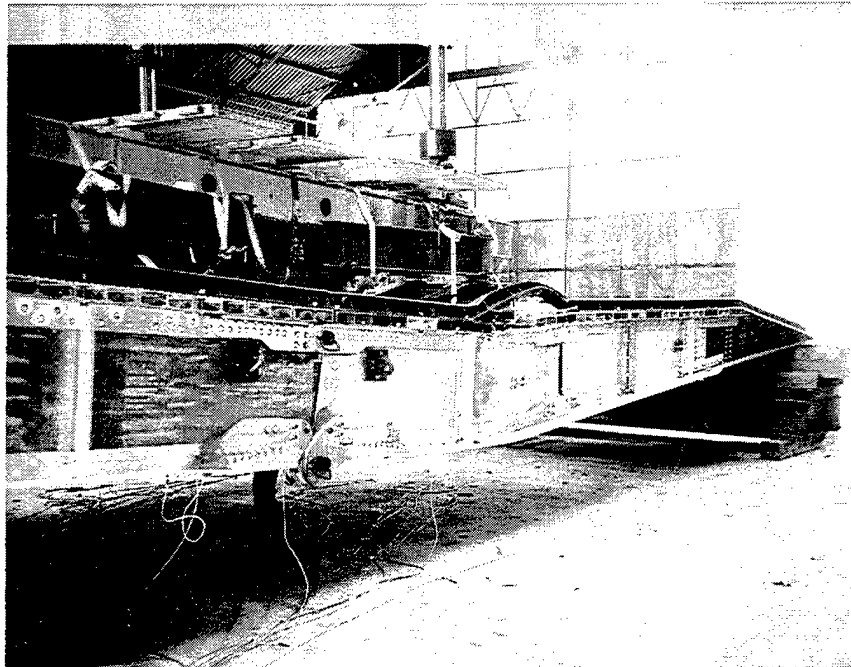
Figure 123. A view of the other side of the collapsed No. 2 bridge in Figure 121. It buckled in the top chords and girder plates in the center panel assembly of the other female bridge section.

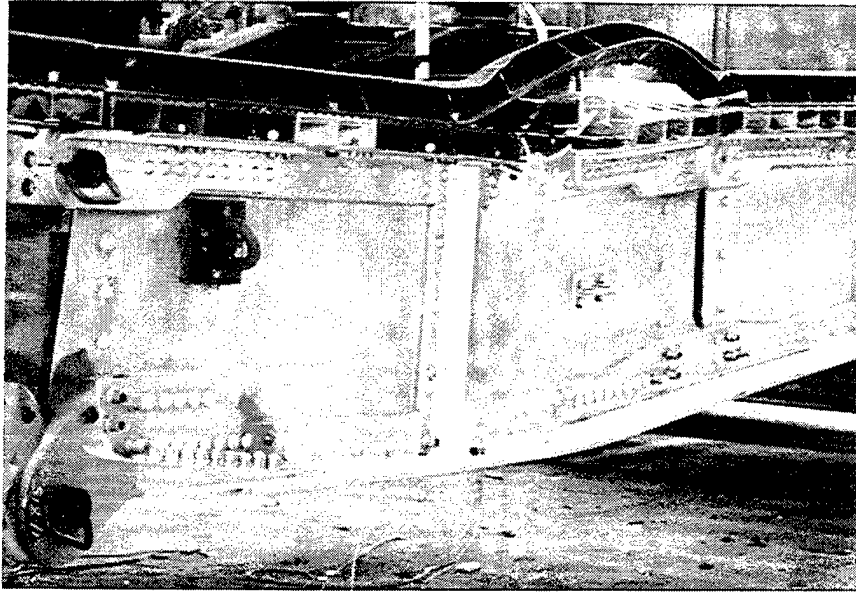
Figure 124. Close-up view of the buckled area in the No. 2 bridge in Figure 123. Note the extensive damages to the top chord, girder plate, extruded aluminum deck panels, and steel curb. The modified bottom chord angles did not crack, but bent at the buckled area.

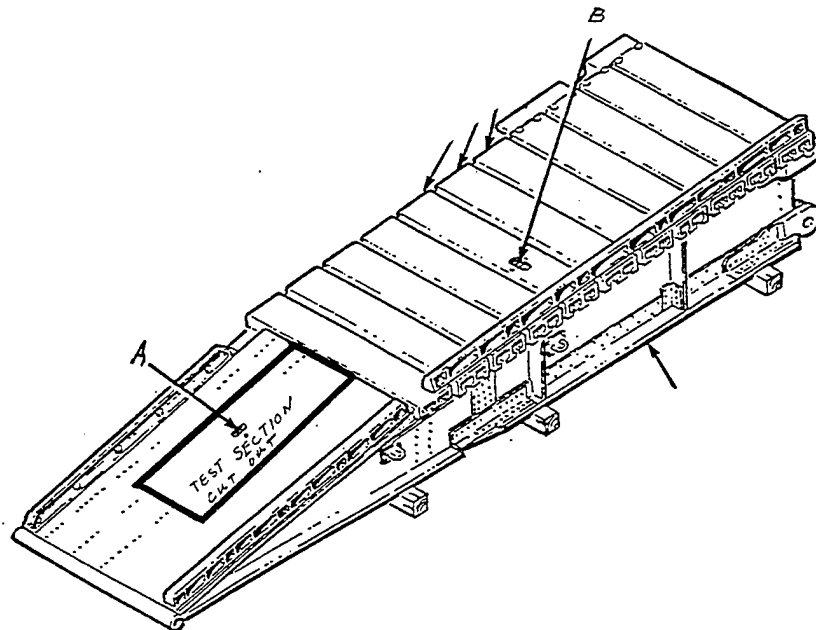
- Another original lifting steel bar was removed from the same AVL B end panel from which the large test section was cut. It was at location B in Figure 125. The bar was installed in the test section

Figure 125. Sketch of the AVL B end panel assembly showing the location of the large test section cut from the lower ramp end with respect to the location of the lifting bar at point A.
